February 4, 2005

RE: Sub-Slab Soil Vapor Monitoring

**ATTACHMENT A**  
**Summary of Monitoring Operations**

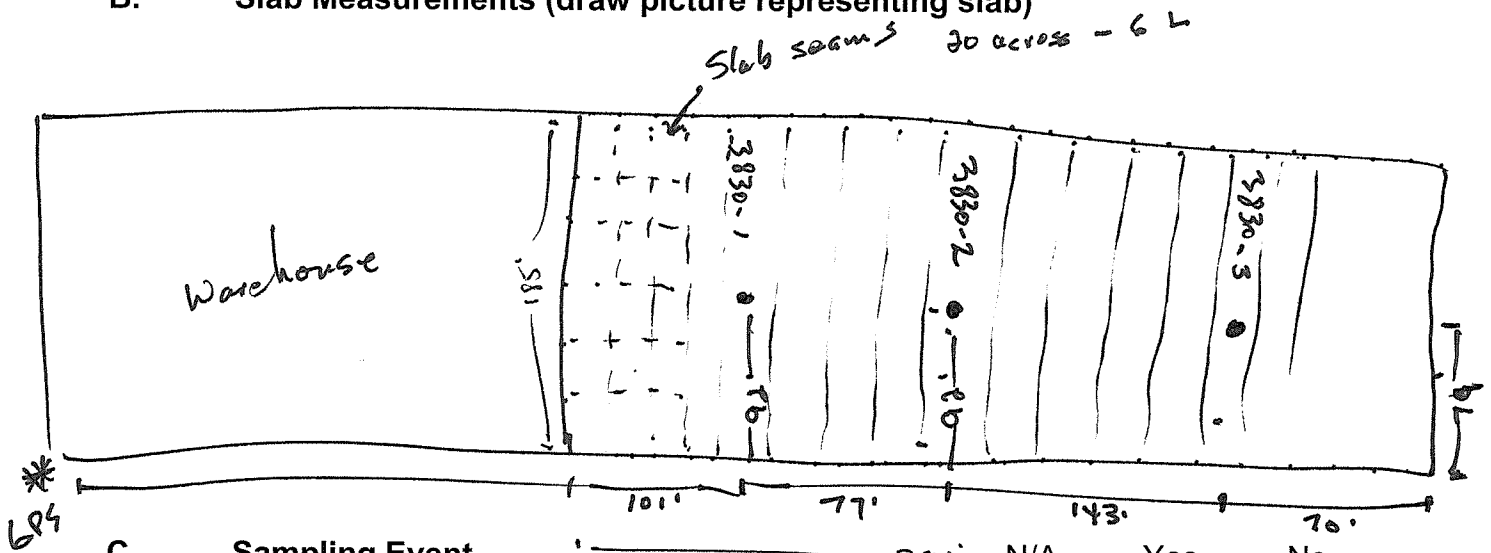
- Slab has hairline fractures in various locations.
- Area where sample collected - No fractures in immediate area within 10'

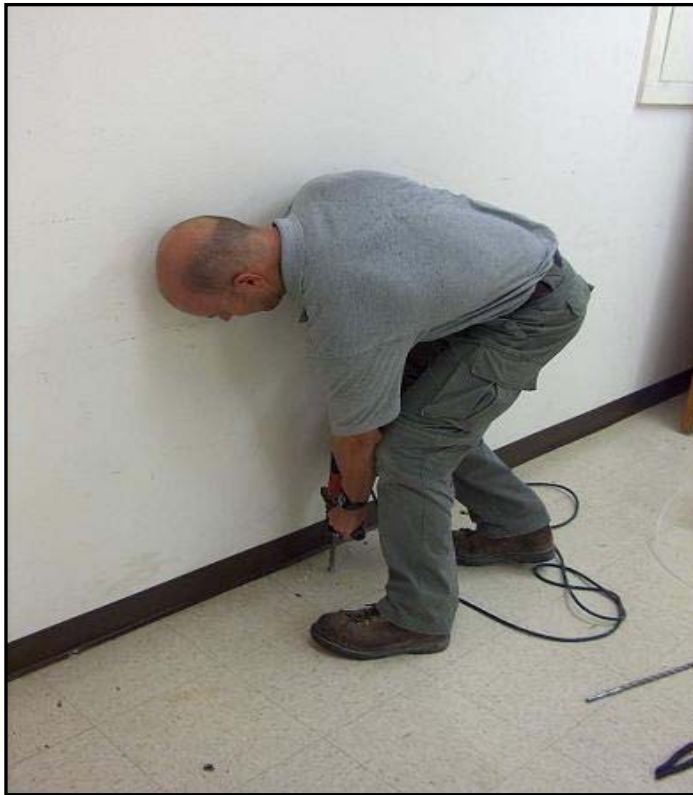
**Photo 1 – Drilling hole for Sample 3187-1.**

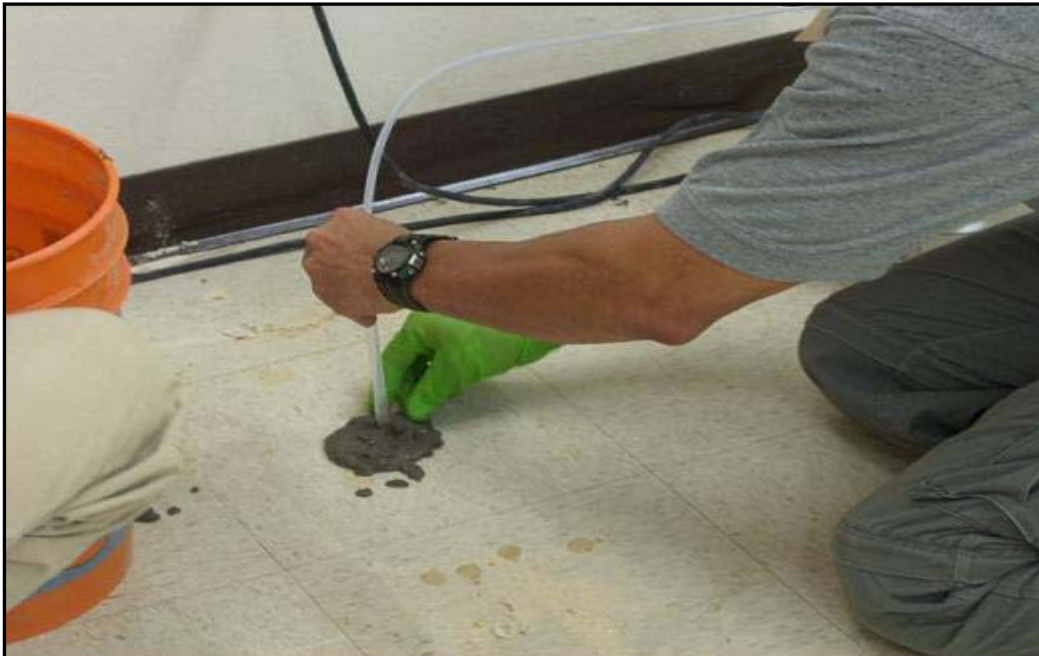
**Photo 2 – Inserting probe and sealing with concrete patching compound.**

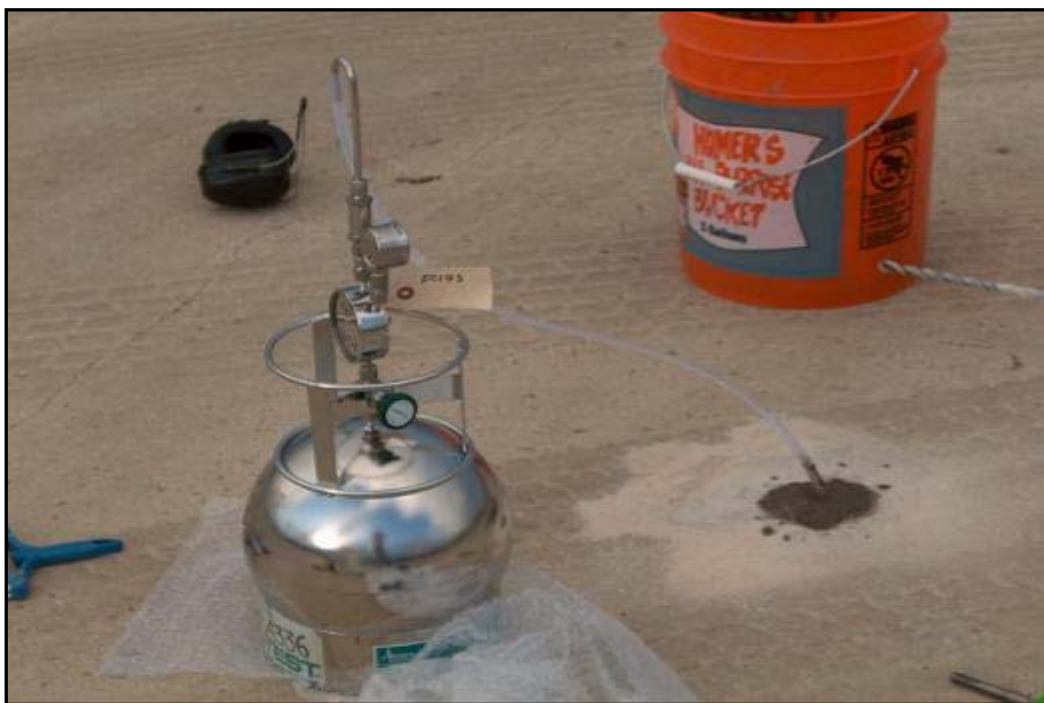
Photo 3 – Sample 3830-2 collecting sample.

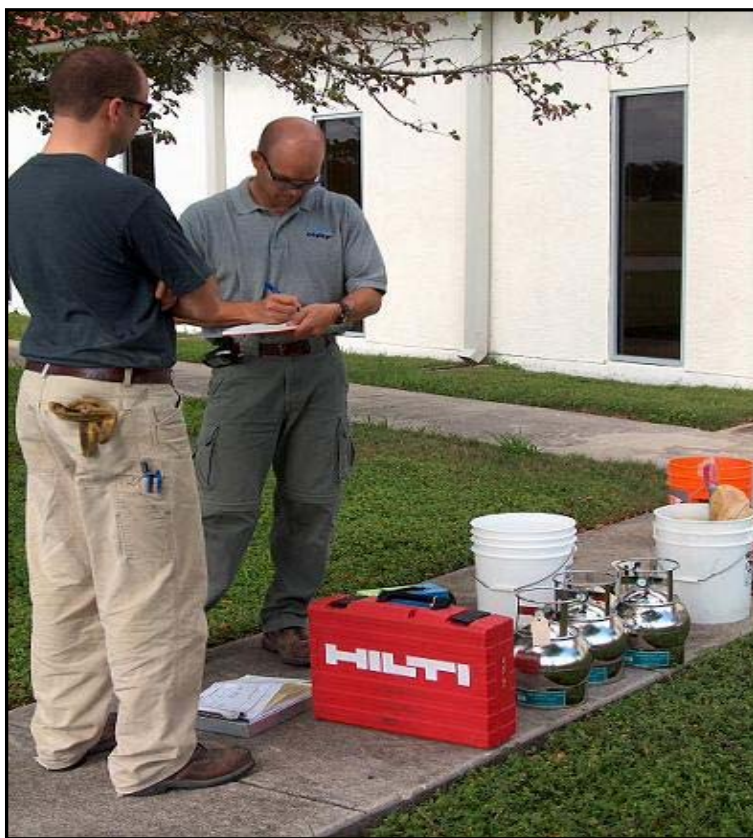
Photo 4 – Completing COC at Bldg. 3187.

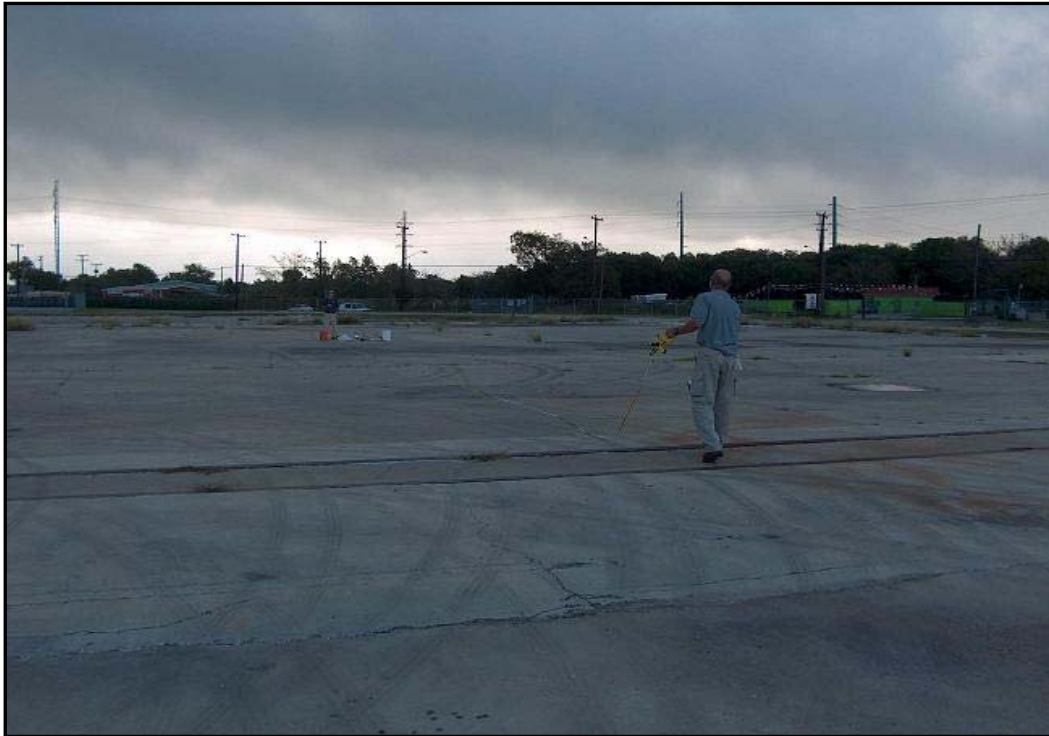
**Photo 5 – Measuring slab at Bldg. 3830.**

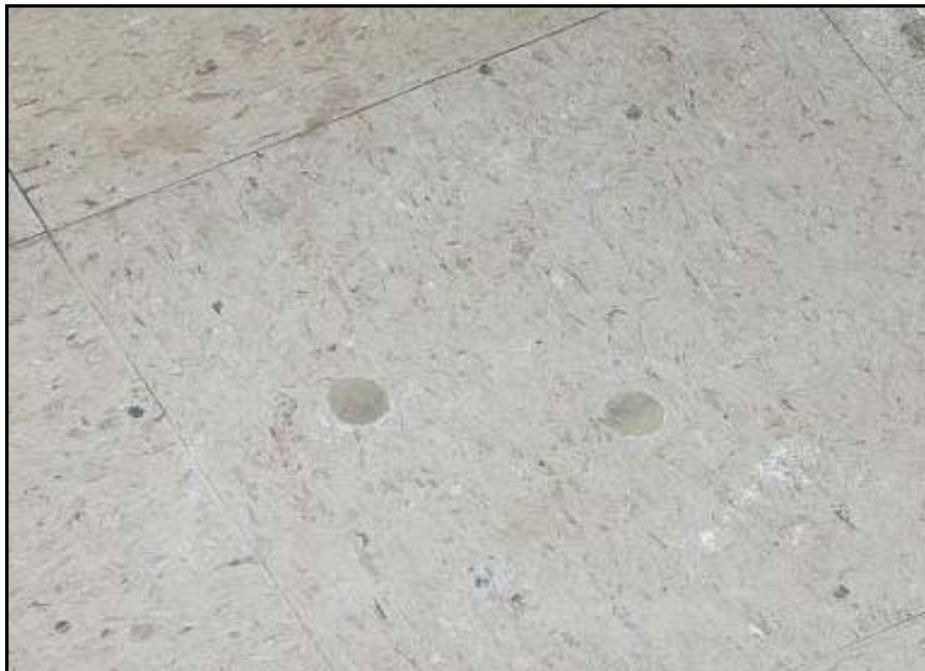
**Photo 6 – Grouted holes at Bldg. 700.**
